FURTHER STUDIES OF ATCRBS BASED ON
ARTS-III DERIVED DATA

A. G. Cameron

Massachusetts Institute of Technology

1. Report No. FAA-RD-74-145	2. Government Accession No.	3. Recipient's Catalog No.	
4. Title and Subtitle Further Studies of ATCRBS Based on ARTS-III Derived Data		5. Report Date 13 December 1974

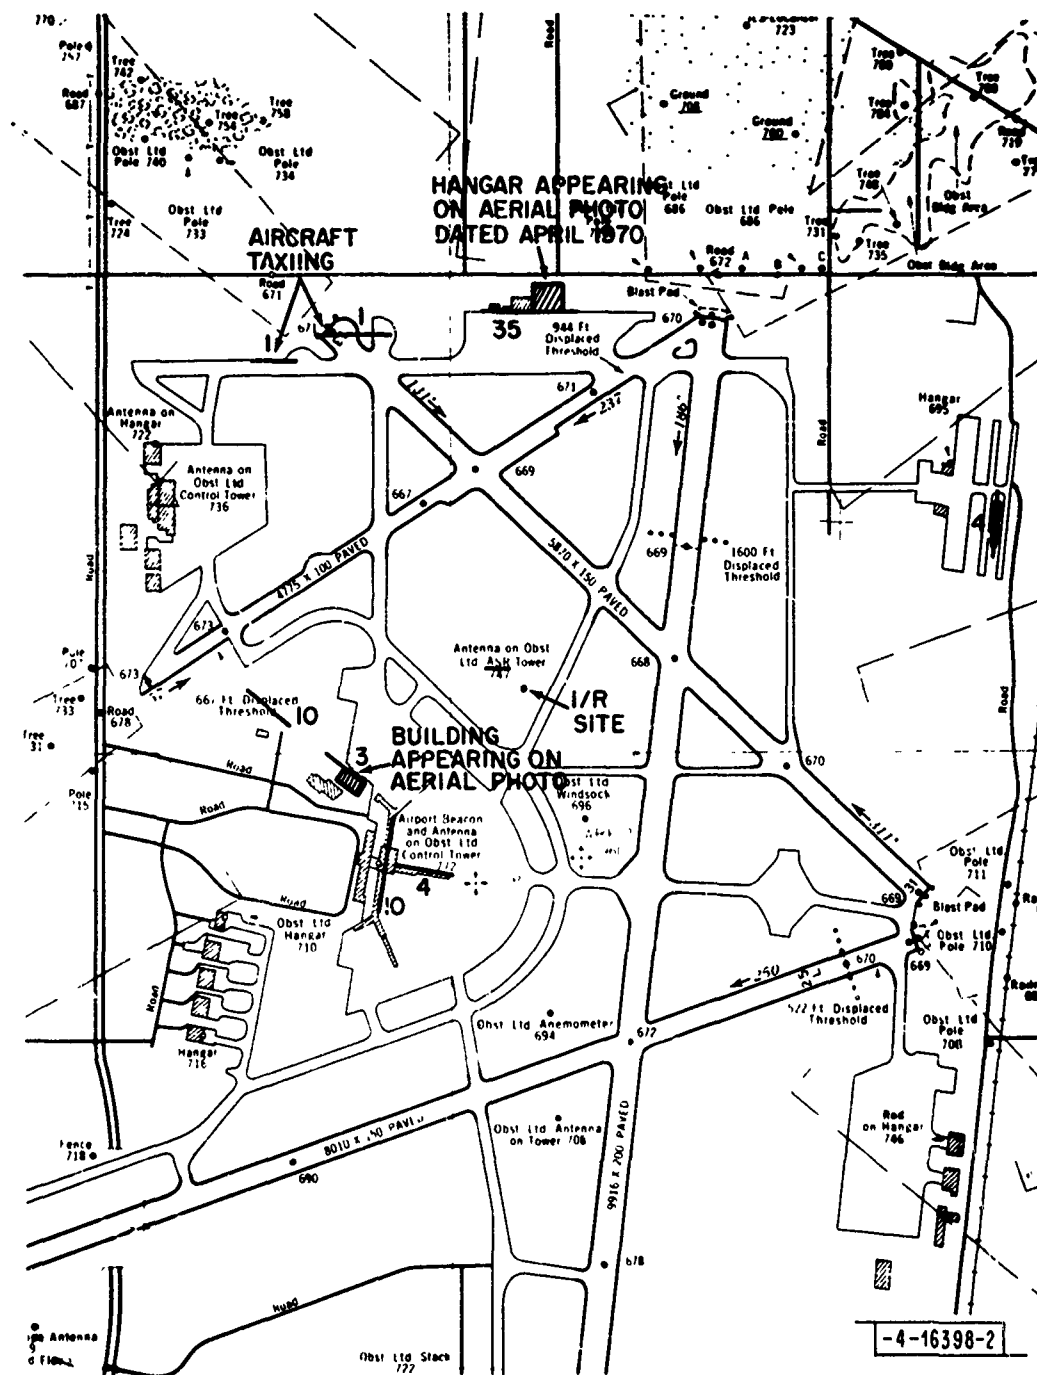
Fig. 2. Location of Reflectors at MKE.

(Numerals refer to quantities of false target declarations caused by each reflector during observation interval)

when the reflected interrogations were received. According to MKE personnel, Improved ISLS was in operation, and the output power level in use at the time was 330 W; this corresponds to an effective Improved ISLS range (Table 2) of approximately 25 nmi. Thus, a major fraction of the false targets should not have occurred. Similar behavior was observed at Andrews, where Improved ISLS should have eliminated many false targets, but did not. It appears from this data that I^2SLS is not functioning properly at either site; the only data analyzed that indicates conclusively that it is functioning somewhere is from Albuquerque (Section 3.3 following). In all of our data from sites other than ABQ, numerous false targets occur at all places where they would be expected, based on examination of obstruction charts. ARTS-III extractor data does not provide sufficient information to allow any inference as to why I^2SLS is not functioning properly. In order to get more information in this area, MKE personnel agreed that they might try increasing the omni (I^2SLS) power for both P_1 and P_2 by a few hundred watts, while holding the directional power constant, and observe whether this affects the incidence of false targets. This would also result in the narrowing of legitimate targets (due to conventional ISLS action), and so should be done only in small increments. Regarding a more complete long-term solution, it appears that the software false target elimination procedure discussed in Sections 3.3-6 and 3.3-7 below would successfully eliminate all the false targets observed.

are due to large building surfaces in close proximity to the I/R, which subtend relatively large azimuthal segments. The surface responsible for most false targets was oriented broadside to the I/R. This has been the case at Andrews Chicago [2], Trevoise [3], and Newark [4], and is undoubtedly the cause of most false targets in the FAA's system. It appears that the FAA ASR siting processes which have been used in the past leave something to be desired, and that guidance to siting parties (such as Spingler's, "Experimentation and Analysis of [ATCRBS] Siting Criteria" [5]) came about too late.

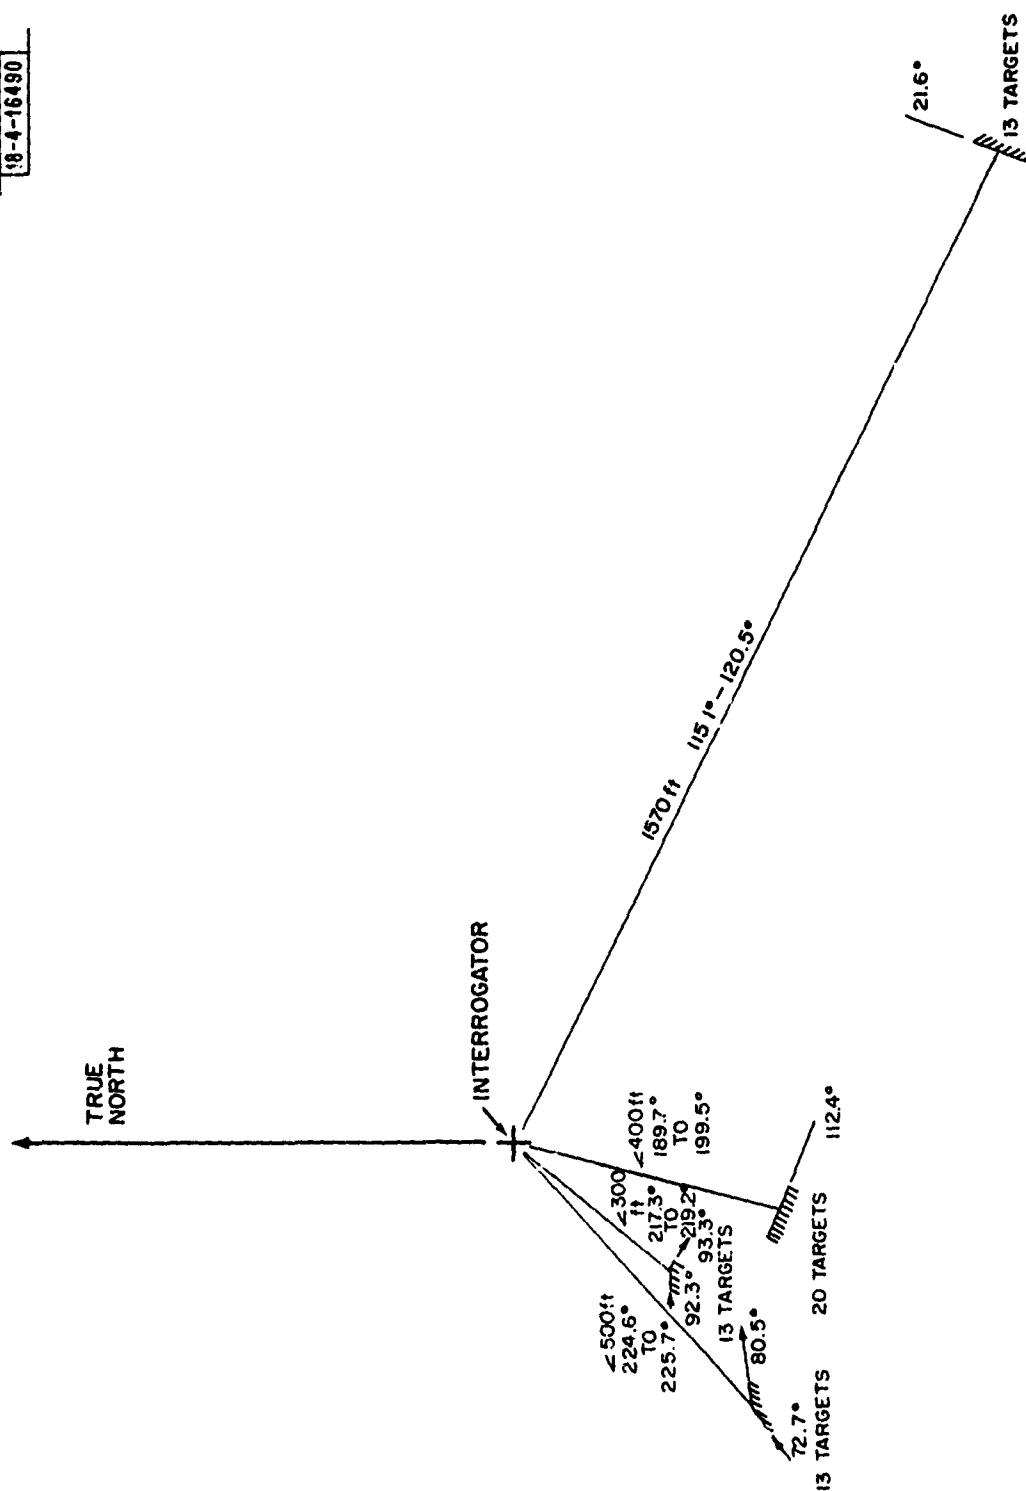
Fig. 4. Reflectors noted at Suitland

As noted, approximately 60 discrete-code aircraft were within the coverage area over the 32 scans examined. The target code listing was examined for instances in which any discrete code appeared at azimuths other than that of the actual aircraft. Of course, splits and dual occurrences of the same codes apparently assigned to two different aircraft were not counted. Fifty-nine instances attributable to reflections were noted in the 32 scans; all were consistent with reasonable reflection geometries.* That is, the false declarations were always at ranges between 0 and 2 miles greater than the instantaneous (interpolated) positions of the actual aircraft, and at azimuths removed by many degrees from those of the aircraft. The 59 false declarations were grouped in azimuth and found to fall entirely with 4 distinct narrow azimuthal sectors; all data pertaining to any one of these sectors agreed quite closely with regard to reflector orientation and range (well within a degree in orientation, and $1/8$ nmi in range difference). The locations and orientations of the reflecting surfaces responsible for the false targets are shown in Fig. 4. As can be seen from that figure, two surfaces appear "bent." In each case, the calculated orientation angle appeared different at one extreme of the reflector azimuth segment than at the other. Differences are larger than can be explained from measurement inaccuracies, and are due either to edge diffraction, to the presence of two separate reflecting surfaces close to one another, or to some combination of these effects. In the case of one of the reflectors, half of the data samples fell to one side of an azimuth near the center of the reflector, and resulted in orientation angle data tightly

The lengths of the false target tracks resulting from these reflectors varied widely: several only occurred once. A few occurred on 4 or 5 scans in sequence. One false target track, due to the reflector at 190° , continued over 11 scans within the 32 scans which were examined. That particular track was followed past the 32nd scan, and found to persist for a total of 51 scans* (slightly more than 8 minutes!). During that occurrence, the actual aircraft range decreased from 57 nmi to 20 nmi, and azimuth varied by about 8° (the aircraft was apparently inbound to DCA). Of course, false target position varied in a similar fashion.

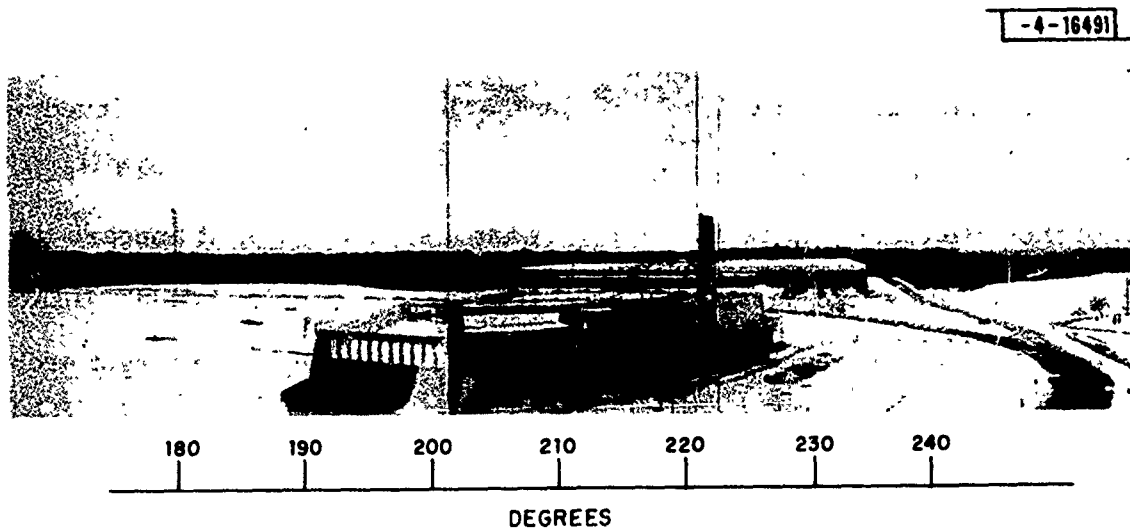
Fig. 5. Southerly sector of panoramic photograph taken from Suitland, MD. ARSR.

Upon completion of the false target analysis, discussions were held with Washington ARTCC and ECAC personnel about the surroundings of the radar. They noted, and a subsequent panoramic photo confirmed, that there is indeed a building at close range to the south, whose shape fits the pattern

The incinerator building looks to be about 150 ft long; it would certainly be possible to modify its surface to cure the reflection problem it causes. Modifications of this sort would undoubtedly alter the lines of the building substantially. The other building, on the other hand, appears quite long, and probably prohibitively expensive to modify.

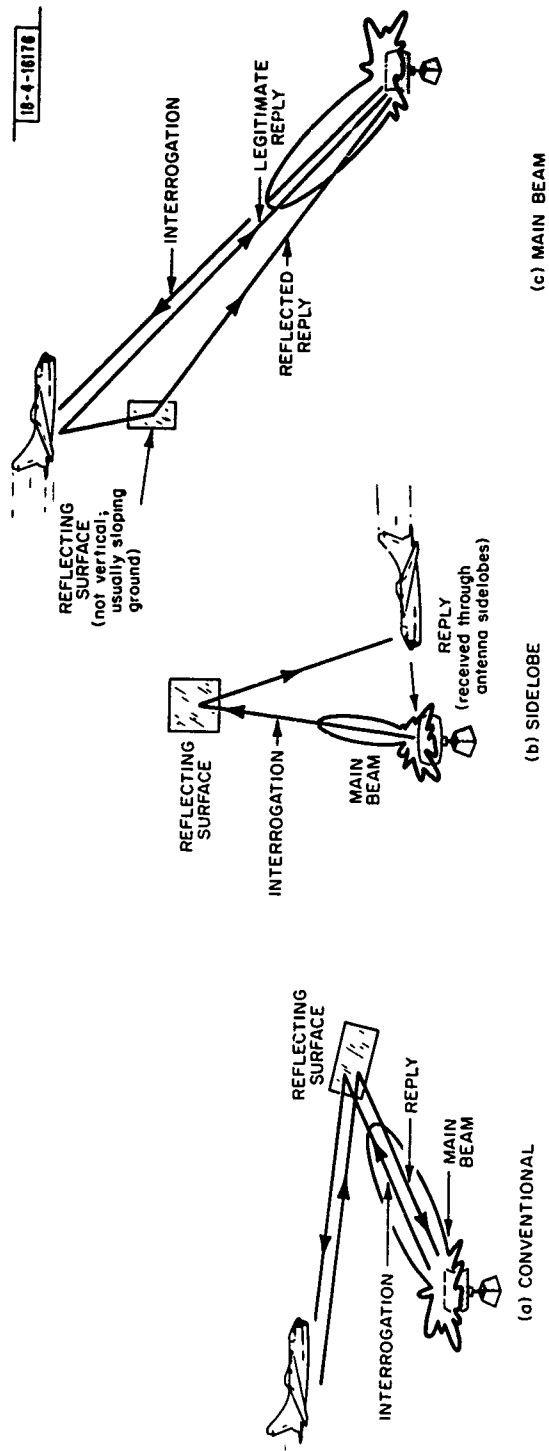
Fig. 7. Types of false targets

"Mainbeam" false targets, or range splits (Fig. 7(c)). These have been observed only rarely, and are problematic to our knowledge only at the Las Vegas, Nevada ASR. They result from reflection of legitimate replies (during the time the aircraft is in the mainbeam) off of properly-oriented patches of planar ground, also in the mainbeam.

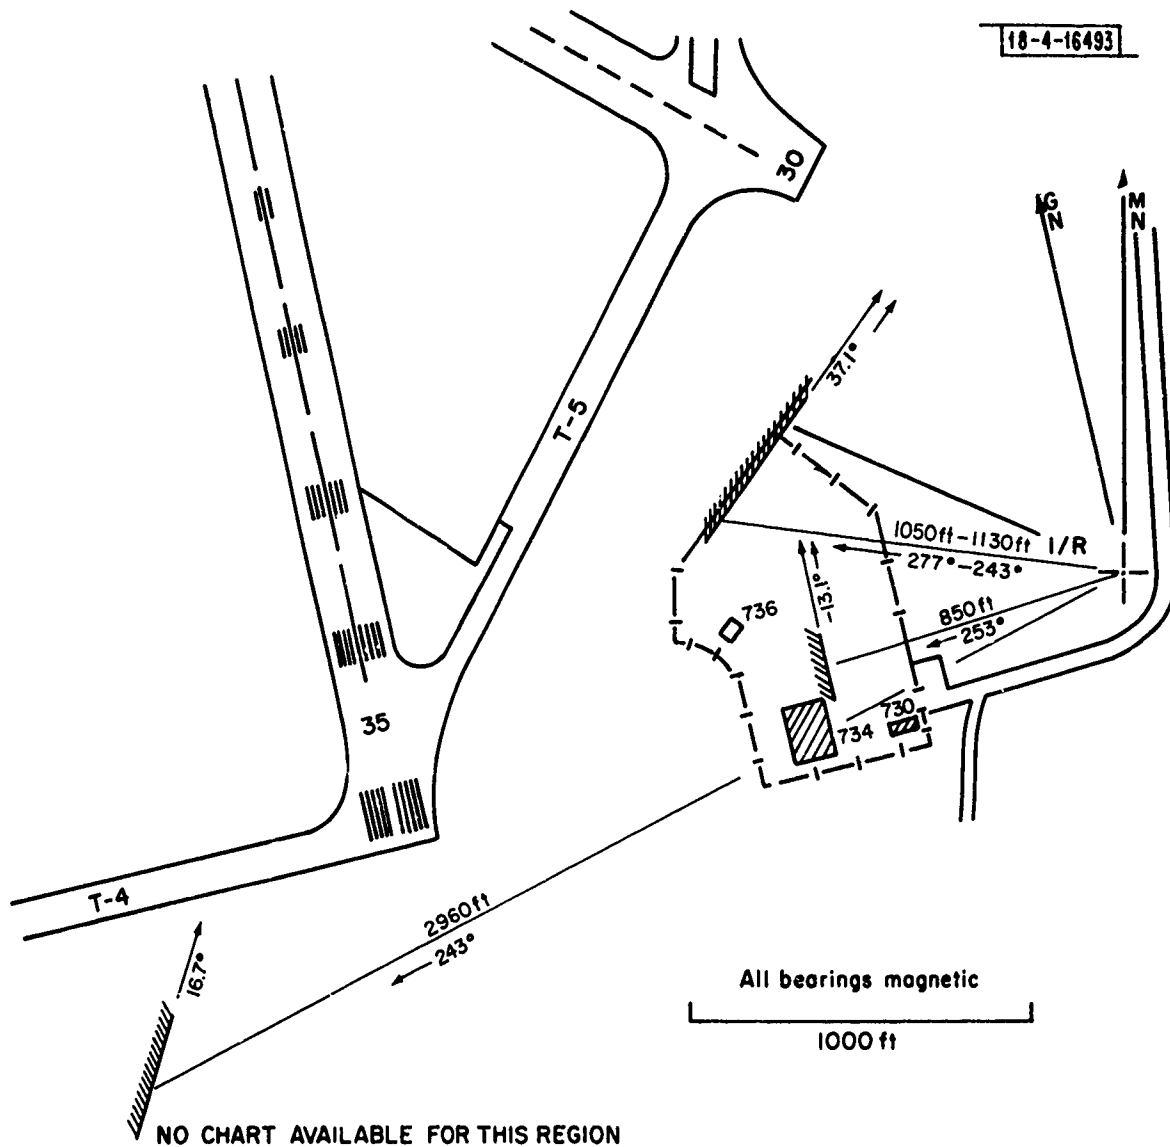
Fig. 8(a). Nearby reflectors - ABQ

The geometries of the 61 false reply sequences were analyzed, and found to be due to 11 different reflecting surfaces. The locations and orientations of these surfaces are as shown in Fig. 8 (a), (b), and (c). (Three separate figures were used for clarity; the reflectors were at quite disparate

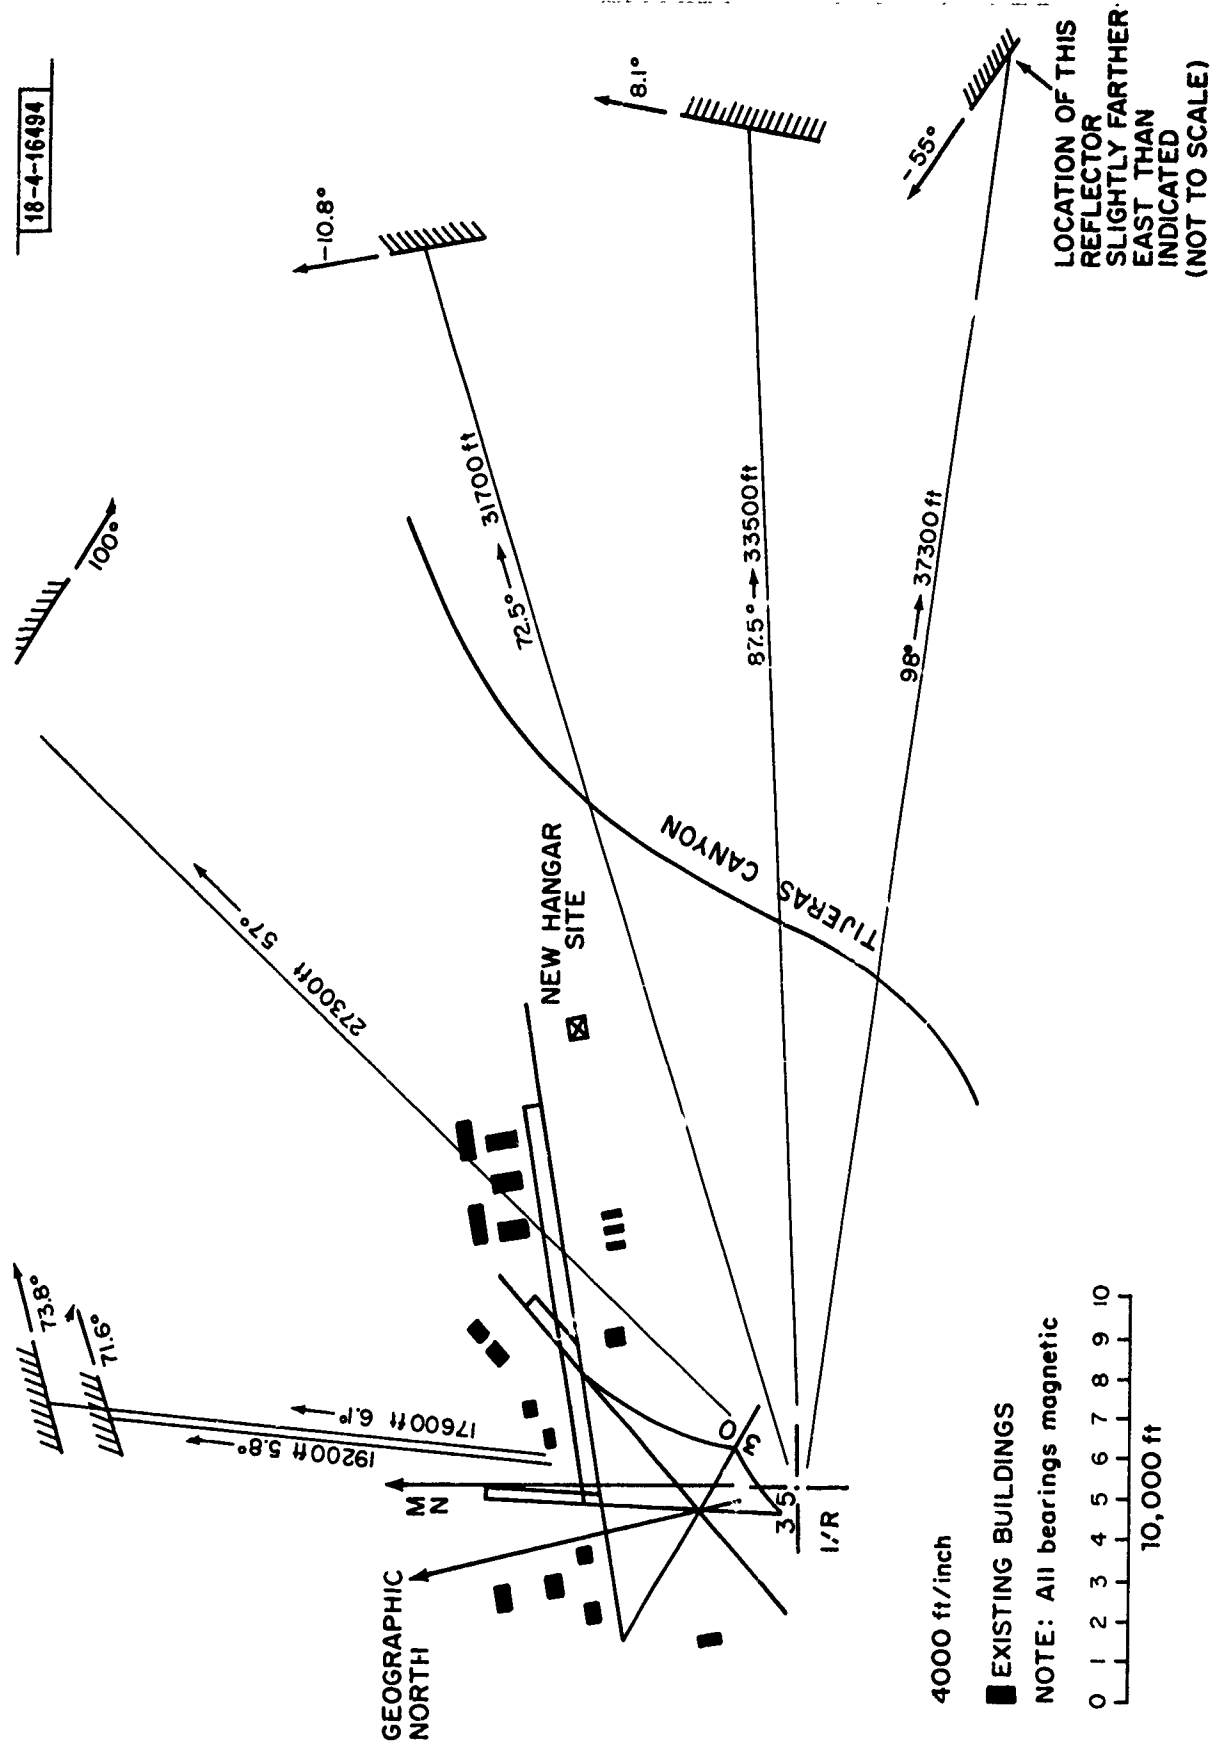
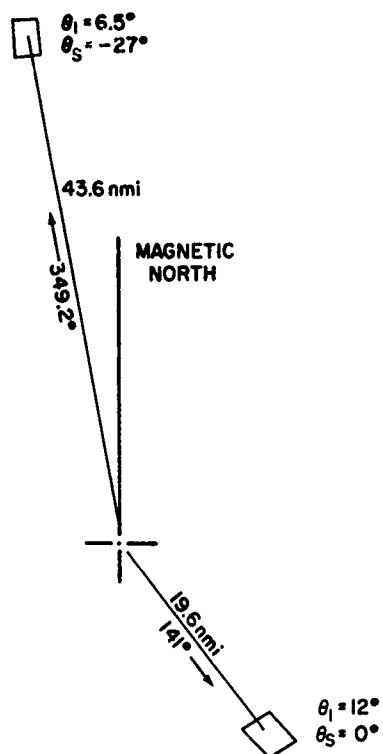
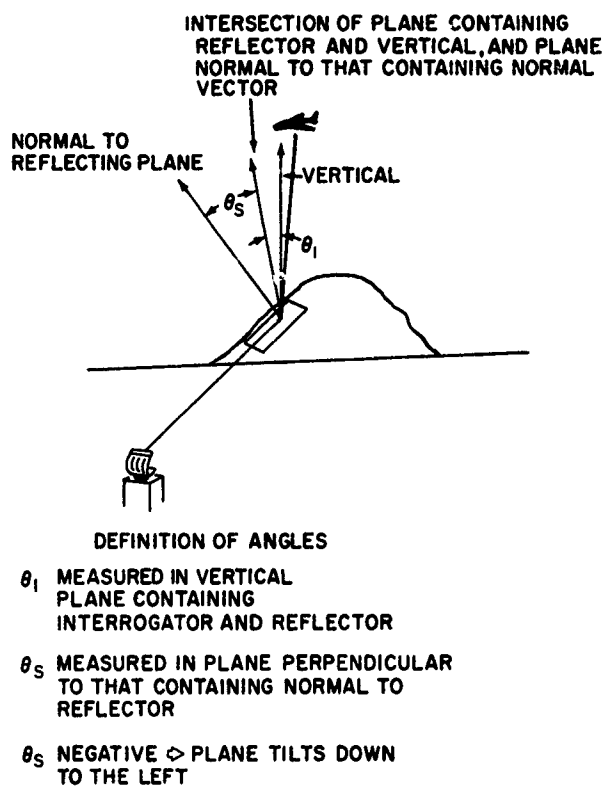
Fig. 8(c). Mainbeam reflectors - ABQ

ranges.) The quantities of false replies caused by these reflectors, compared with those caused by other reflectors at comparable ranges observed in past data from other sites (with appropriate corrections made for differences in system parameters), suggests that several of these reflectors are quite large, and long in extent, notably the two to the East at 72.5° and 87.5° . The reflectors and pertinent parameters are listed in Table 8.

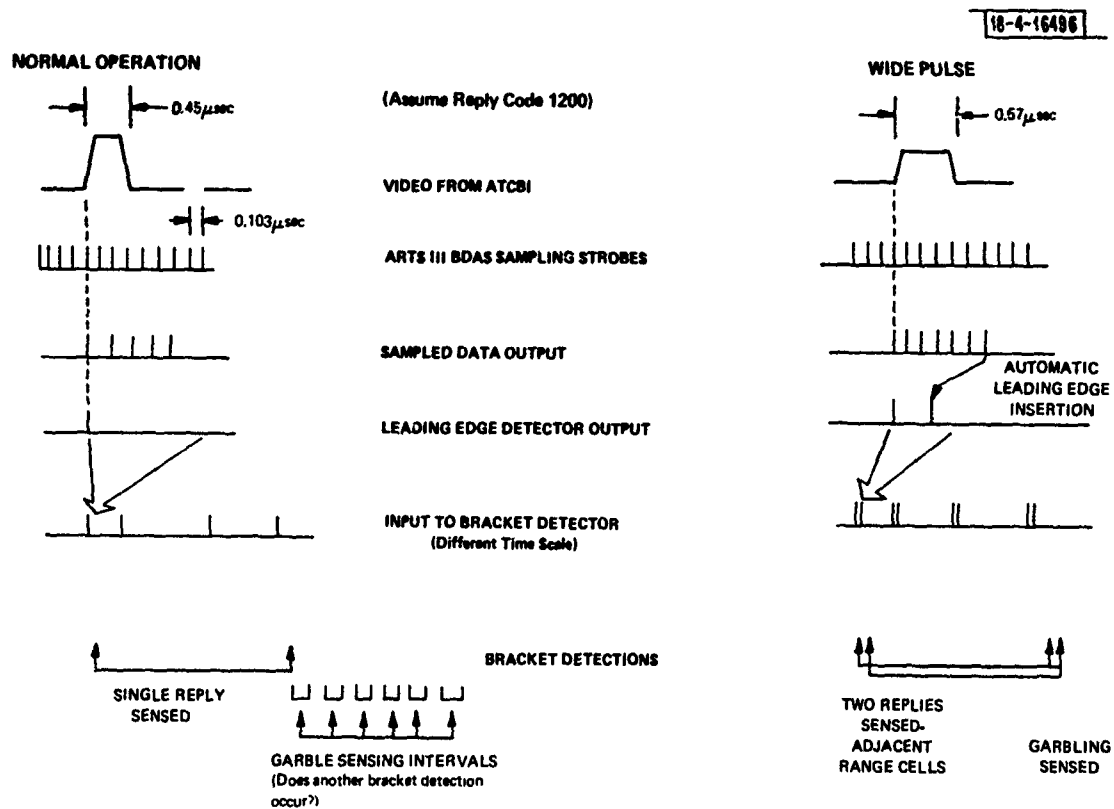
Fig. 9. Effect of excess pulsewidth on reply generation

There are two mechanisms by which ATCRBS reply pulses could be widened excessively: short time delay multipath and ATCBI receiver/ARTS-III front-end misalignment. Instances of both have been seen in past data. Indeed, two instances of multipath were noted in the 16 November 1973 Albuquerque data (the two "mainbeam" reflectors shown in Fig. 8(c)). However, in both these cases, the replies were separated by two or more range cells (rather than one). This amount of separation is inconsistent with excess pulse-width, and can only result from a channel in which a single input pulse results in a distinct pair of output pulses, separated by a microsecond or more.

and C₂-SPI phantom problems. The wide pulse problem generally caused an additional reply to be generated, and flagged both this spurious reply and the adjacent legitimate reply as garbled. Occasionally, however, pulse stretching would be sufficient to cause the garble sensing mechanism to react, but not to generate the spurious reply. Thus, slightly more than half of the garbled replies were legitimate; for the typical values noted above, this would lead to the conclusion that out of 180 legitimate replies per scan, roughly 30 (16%) were disturbed by the pulse-stretching and C₂-SPI phantom phenomena, during that portion of the data derived from channel 1. The channel 2 data produced a far lower rate, typically 4 or fewer garbles out of 120 replies. These garbles were usually due to legitimate instances of synchronous garbling, and in the few cases seen where they could be attributed to excessive pulsewidth, they were generated entirely by a single aircraft. In the channel 1 data, virtually every aircraft in the coverage area exhibited the problem. On the basis of these data, it would appear that the problems of erroneous garble flagging and spurious reply generation are due to pulse stretching which occurs within the channel 1 beacon receiver. * Since the incidence of this behavior is fairly low even in the channel 1 data (about one chance in six per legitimate reply), the pulse stretching appears slight; ATCBI video output pulses of width only slightly in excess of 550 nsec could cause this incidence. Discussion with site personnel confirms that these pulsewidths are being measured. It should be noted that the national standards for ATCRBS transponders allow pulsewidths up to 550 nsec. It therefore appears essential to hold any pulse stretching in the receiver down to a very minimal value, since only very slight increases in pulsewidth above that allowed will cause severe system performance degradation.

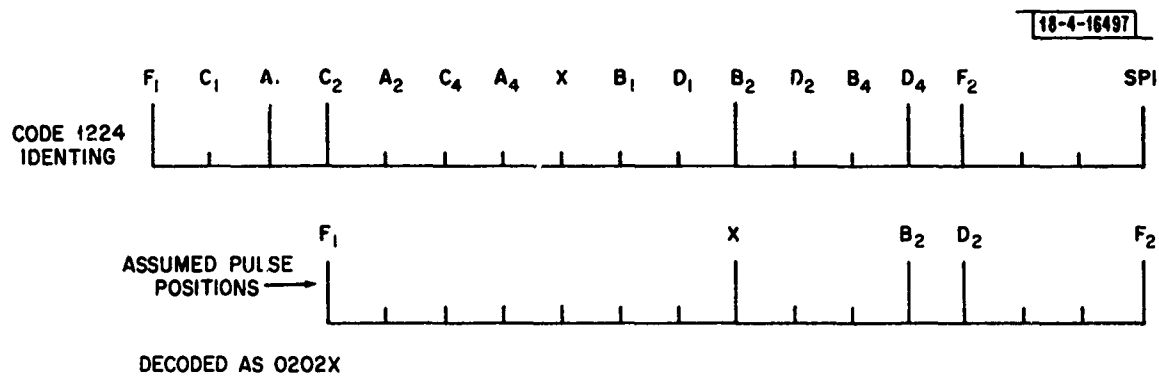
Fig. 10. Generation of a C₂ - SPI Phantom.

This phenomenon was noted on Mode A in connection with SPI operation, which occurred only rarely. It was far more prevalent on Mode C; early specifications for altitude encoding transponders (cf. Ref. 7) required that the SPI pulse be set in a Mode C reply whenever the D_4 pulse was set. Many airline transponders today encode altitude in this fashion; the D_4 pulse only becomes set above pressure altitude 30,800 ft. Three of the aircraft in the ABQ coverage area replied in this manner, and whenever they were at altitudes such that the C_2 pulse was set as well (this occurs about 60% of the time in Mode C replies), their reply sequences contained multiple C_2 -SPI phantoms.

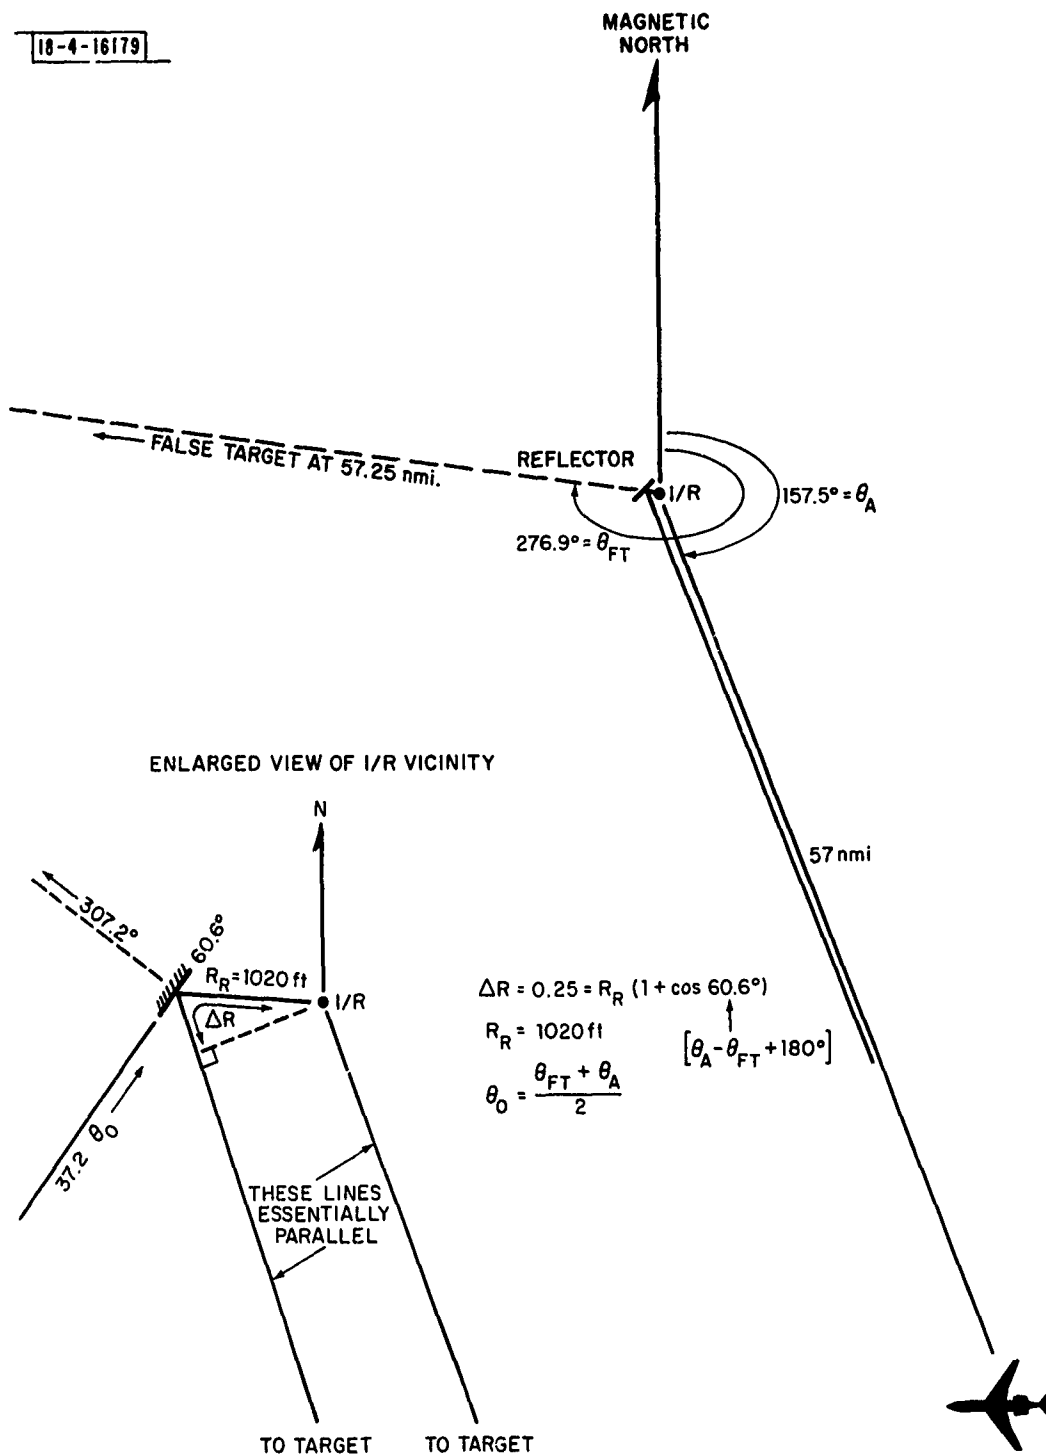
Fig. 11. Simplified geometry $R_A \gg R_R$.

These assumptions appear quite appropriate for the particular situation at Albuquerque. Should they prove undesirable in other applications, it is fairly straightforward to remove their effects from the algorithm. The basic false target elimination algorithm is first described in general terms, and then specifically tailored to the Albuquerque situation. The process involves recognition of aircraft in regions where they can cause false targets, calculation on where those targets would be, search of those areas to see if correlated targets are present, and identification of those targets as false.

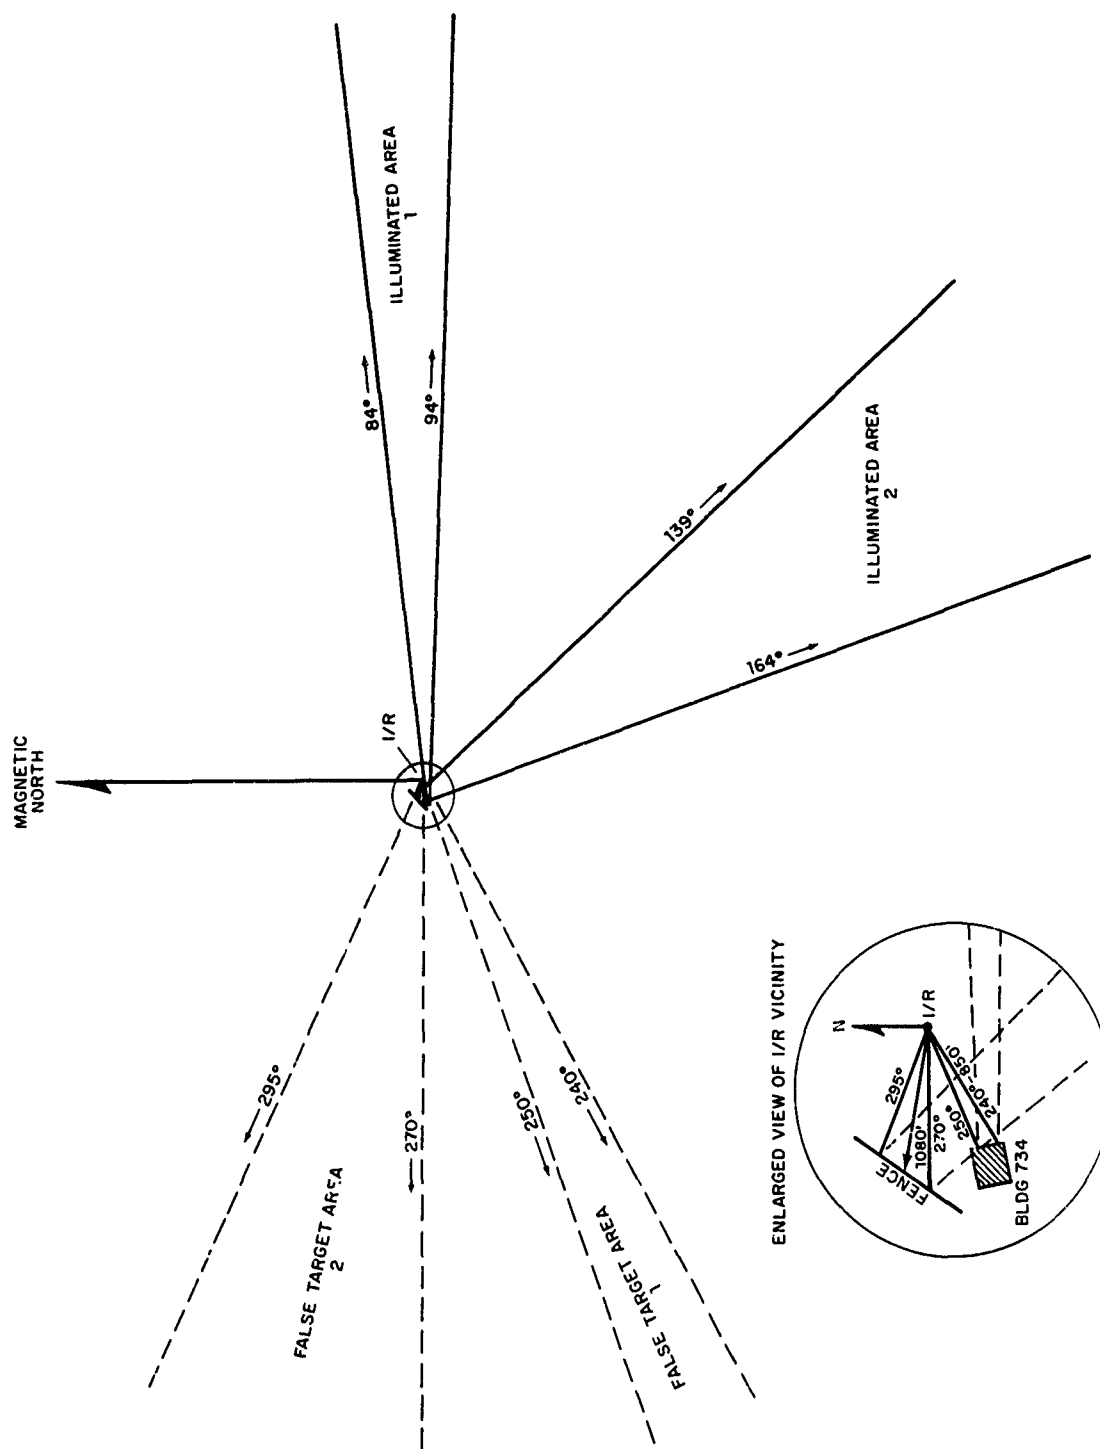
Fig. 12. Typical close-in reflection geometry.
(observed at Albuquerque)

$$\theta_{FT} = 2\theta_o - \theta_A$$

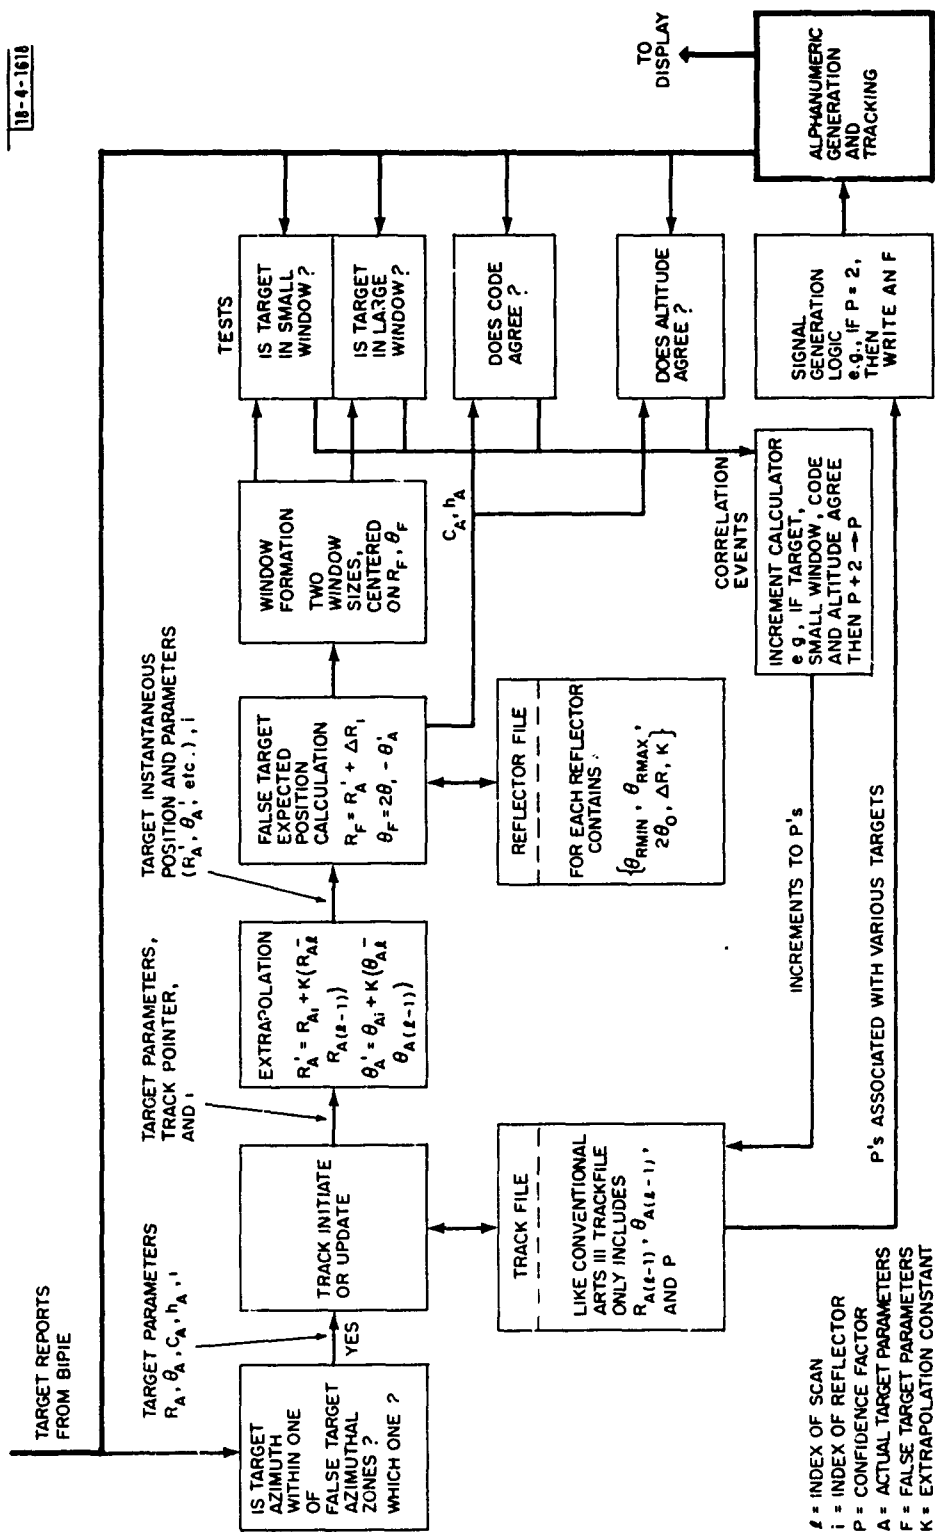
Fig. 14. False target elimination algorithm employing tracking.

It should be noted initially that experience with ARTS-III reply, target declaration, and tracking data has demonstrated clearly that declared target position data yields far higher precision than tracker output data. The only source of noise of the type which tracking can filter out in the range measurement process is quantization; whenever a target is declared, one can be certain that its range is within 1/16 nmi of the proper value. Tracked positions often deviate by more. Thus, only positions associated with target declarations are employed in what follows.

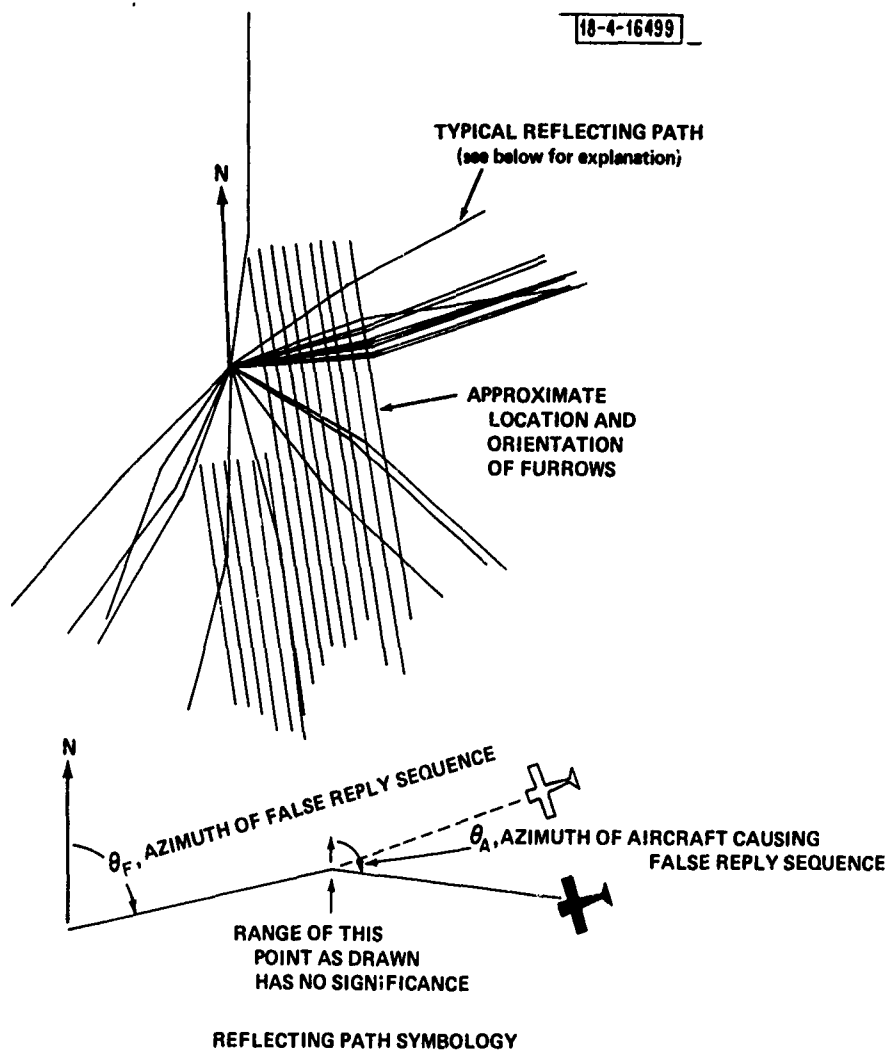
Fig. 16. Peculiar reflection geometry at Ontario.

Several conclusions can be drawn from the available information:

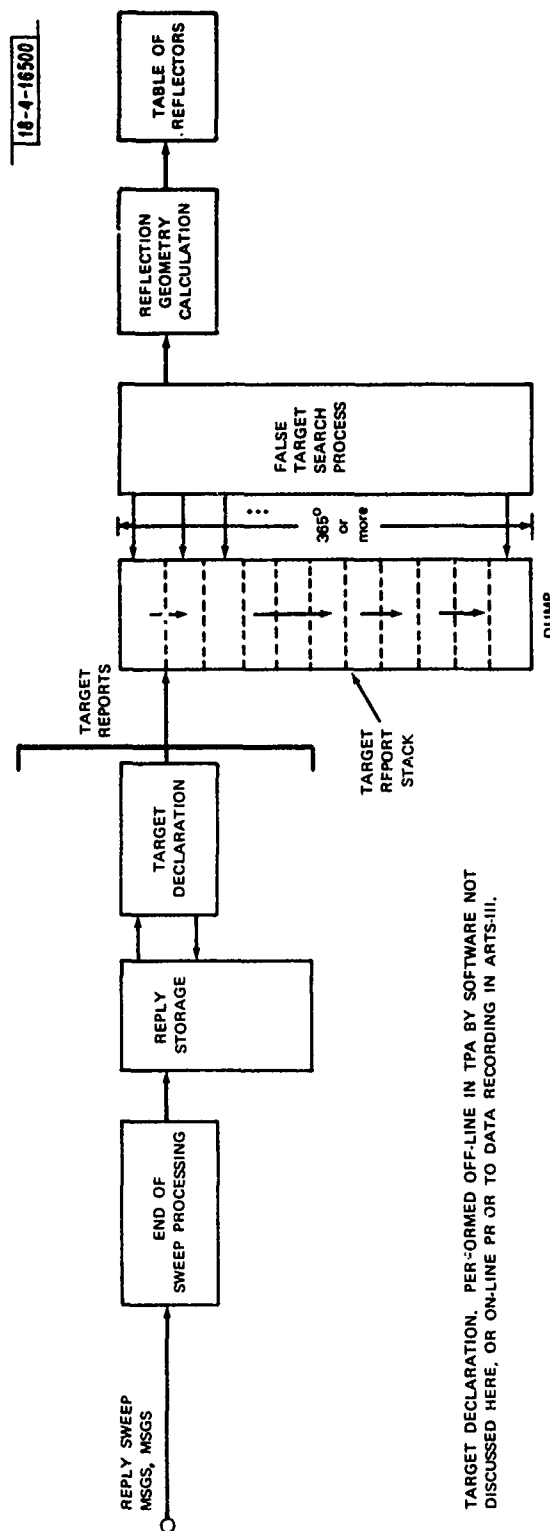
Fig. 17. Target report generation and processing.

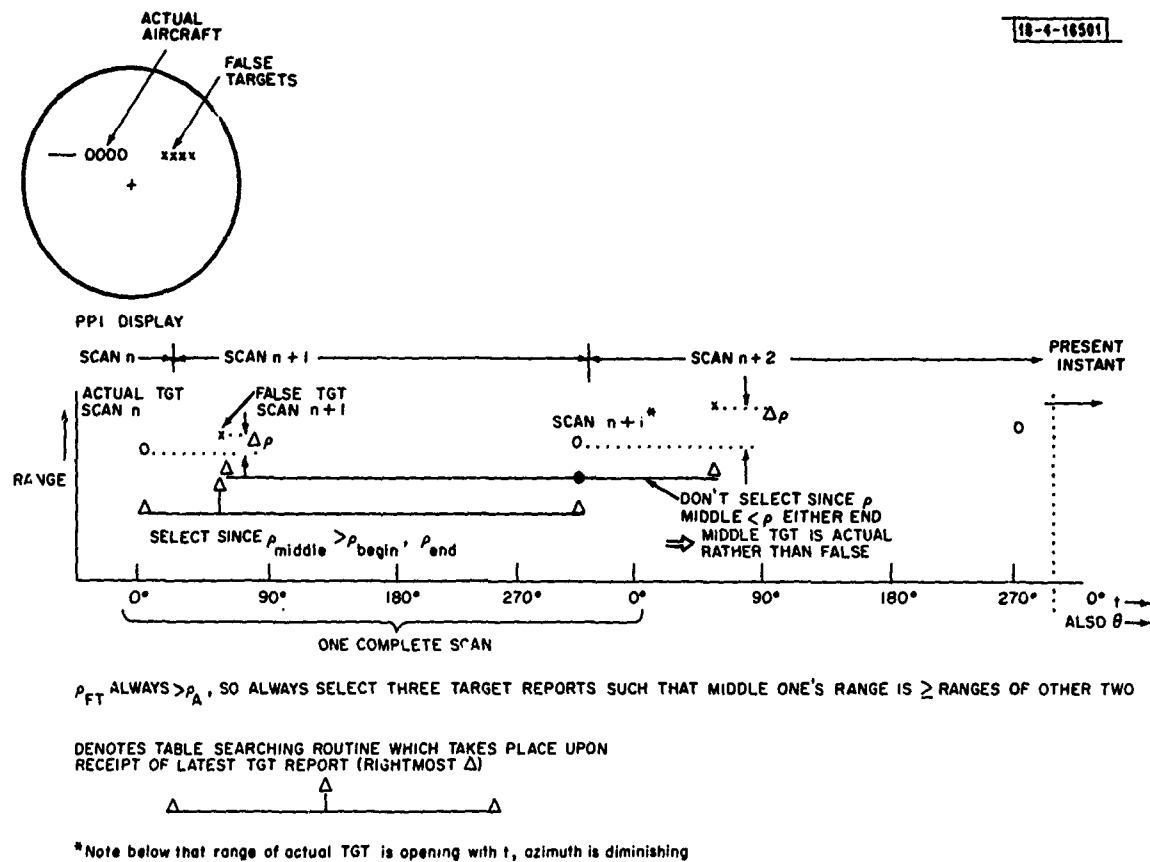
Fig. 18. A typical false target situation.

Assume now that a reflecting surface (say, a building) located east of the I/R is oriented so as to cause this aircraft to generate false targets. (Represented by the X's in Fig. 18.) Due to the excess pathlength the reflected signals will always appear at greater range than the actual aircraft; this allows the processor to differentiate between the actual and false targets.

By scanning the record of target reports on a particular code, the processor determines that a false target is present (on the basis of whether that code is declared at different azimuths on the same scan), and, if so, it determines which target is false and which is real (on the basis of which has the greater range). The information needed to determine reflector geometrical parameters includes false target location (ρ_F , θ_F) and actual aircraft position at the instant the false target was received. This latter data is determined by interpolation of the measured aircraft positions prior to and subsequent to the false target declaration. The output from the false target determination process is, therefore, a set of three locations, that of the actual target prior to generation of the false target, that of the false target, and that of the aircraft subsequent to generation of the false target. The process is as follows:

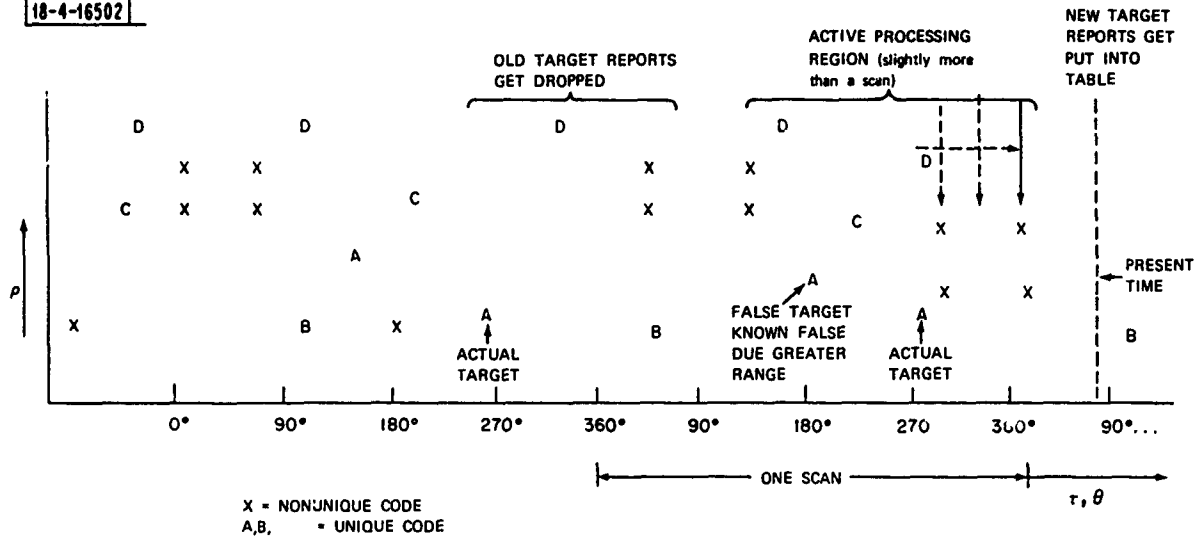
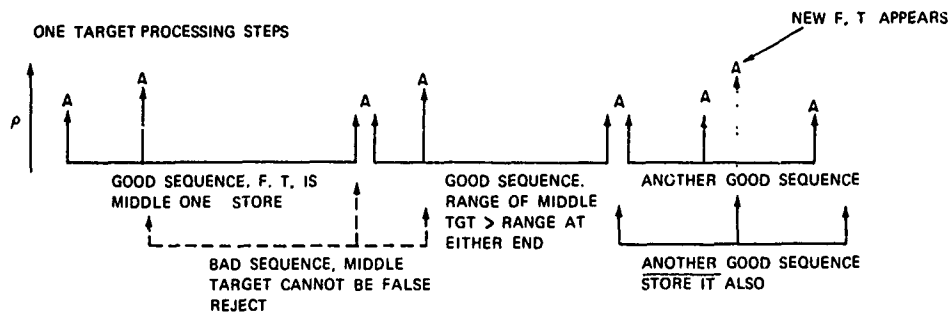
Fig. 19. Discrete-code false target processing.

- If the actual target is within the sidelobe reply range of the interrogator (say, eight miles), and more than one false target is noted at one or more azimuths, then put in "sidelobe" category.
- If in either of the above, put in "conventional" category.

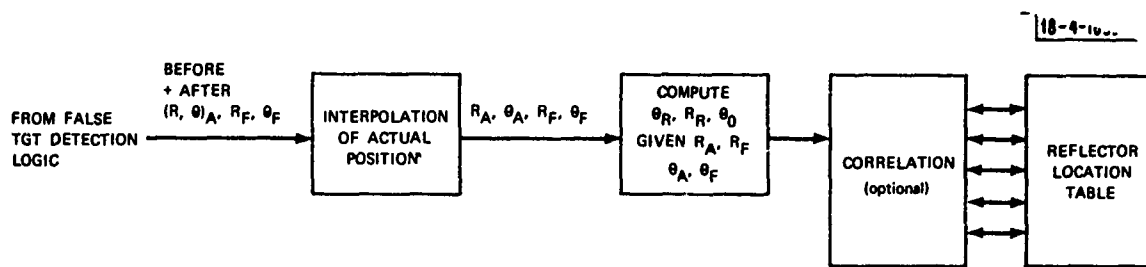
Fig. 20. Conventional flase target processing.

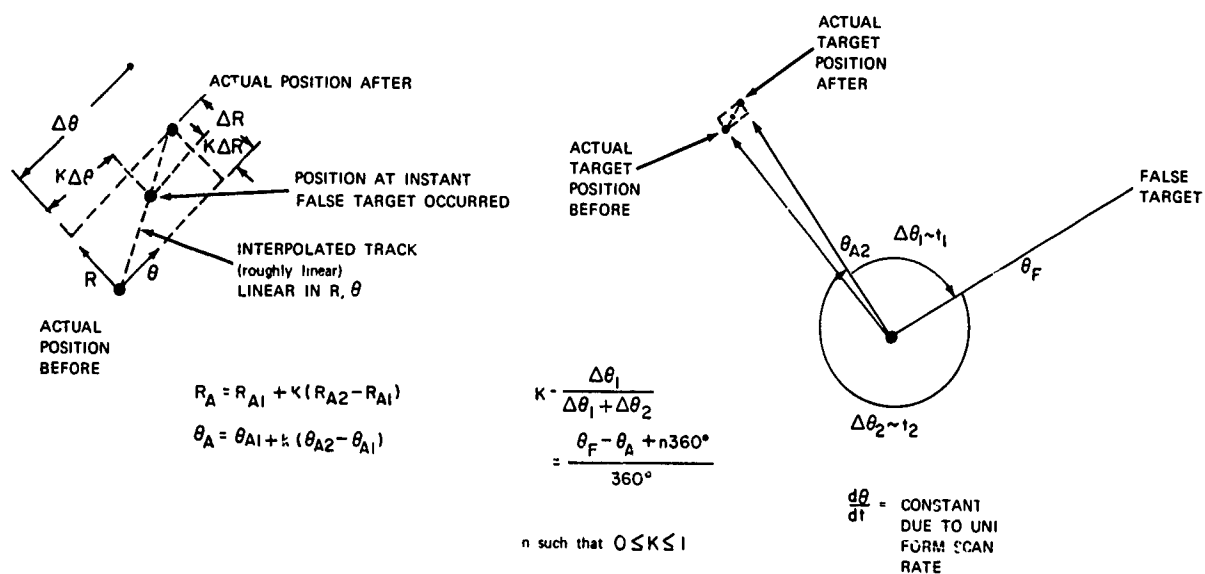
Fig. 21. Actual target position interpolation.
